NPIC/CSD 548/65

27 OCTOBER 1965

NINH BINH COMPLEX
NORTH VIETNAM
2015N 10559E
[REDACTED]

NINH BINH COMPLEX NORTH VIETNAM 20 15N 105 59E

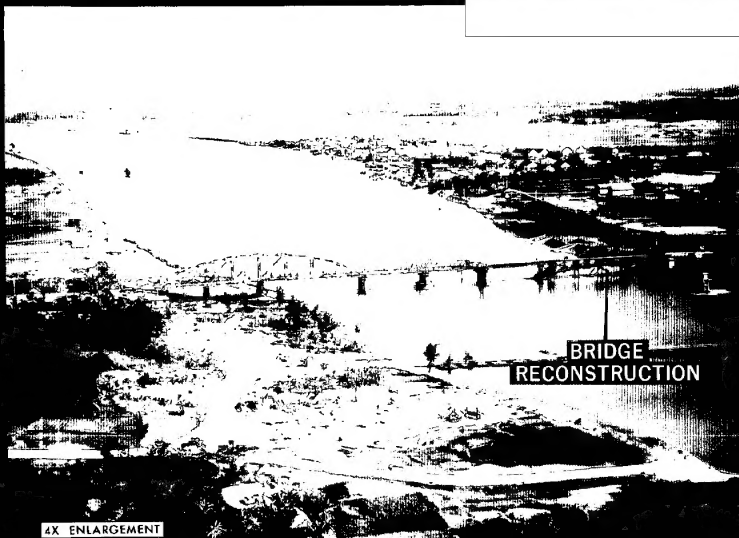
4X ENLARGEMENT

1. PRE-STRIKE PHOTOGRAPHY OF MARCH 1963, REVEALS NINH BINH COMPLEX AS IT APPEARED PRIOR TO AIR STRIKES ON THE NINH BINH RAILROAD AND HIGHWAY BRIDGE [REDACTED]
